Durability of Concrete Bridge Decks

MDOT Project Manager

Steve Kahl, PE
Supervisor, Experimental Studies Group
Michigan Department of Transportation

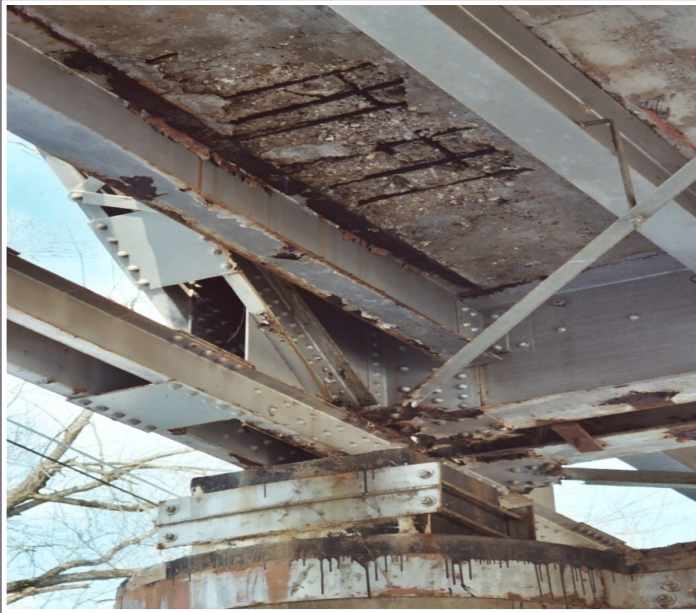
Corrosion of steel & concrete spalling

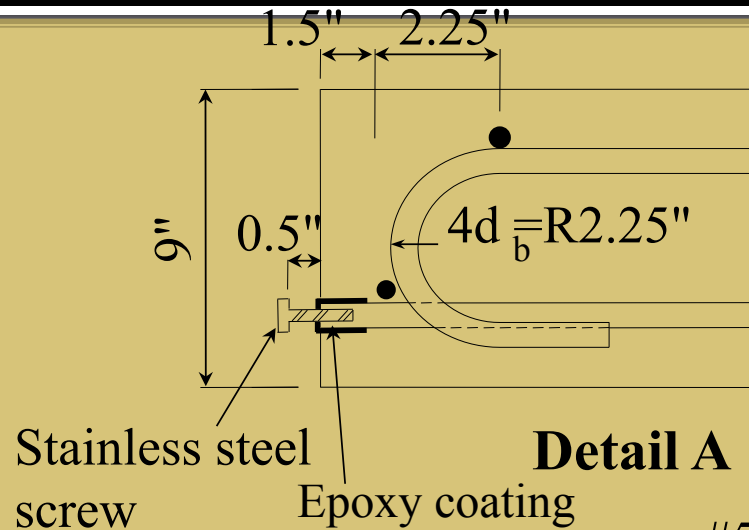
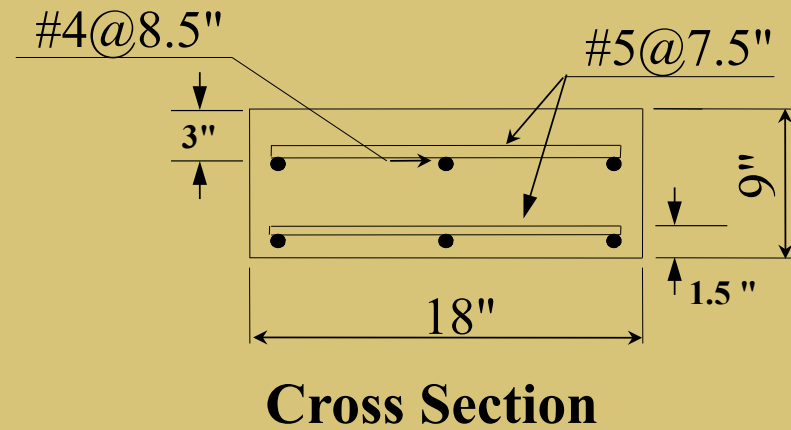
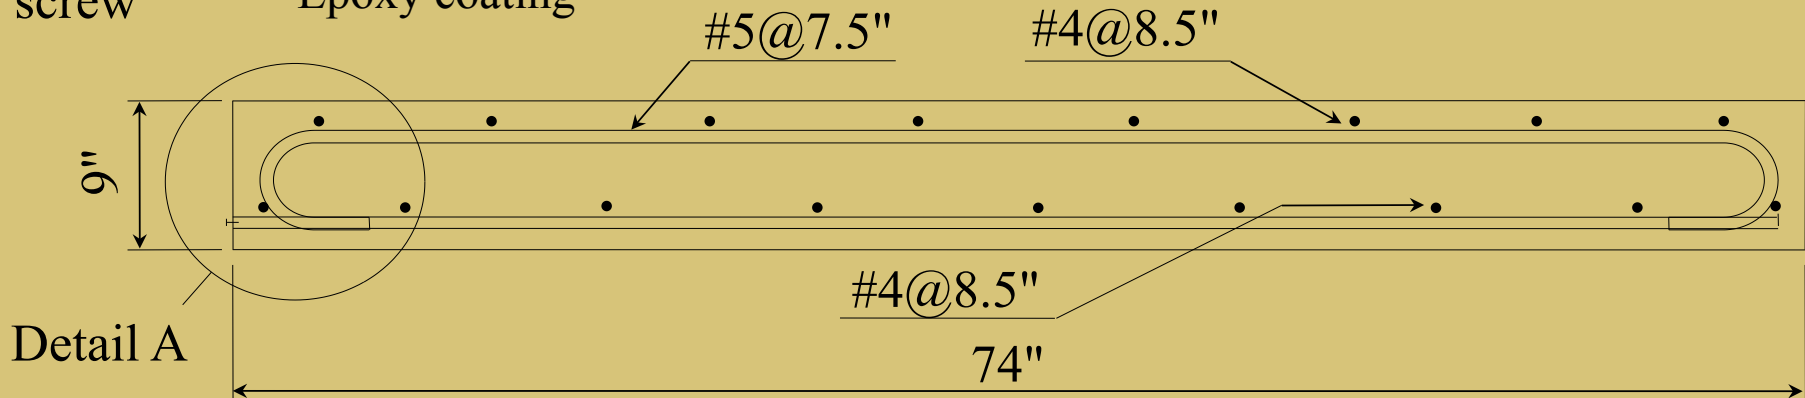
Reinforcement Details for Specimen

#According to MDOT Standard Slab Design
(Load Factor Design)

Elevation

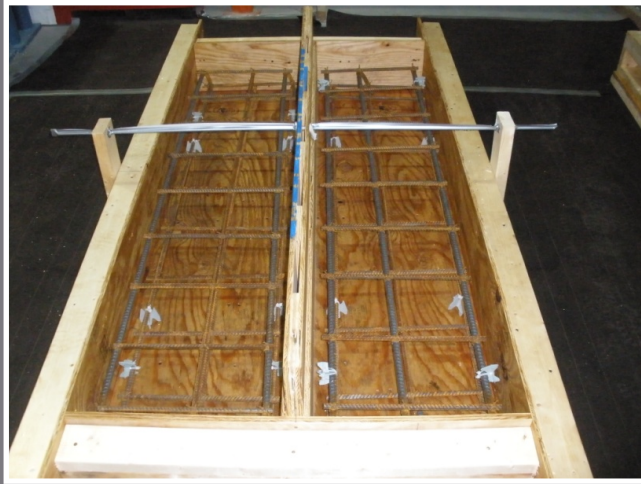
Reinforcement Cage & Form Work

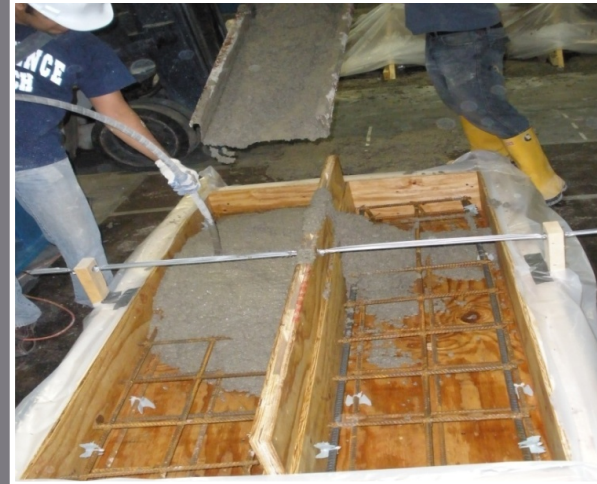
Concreting of Specimens

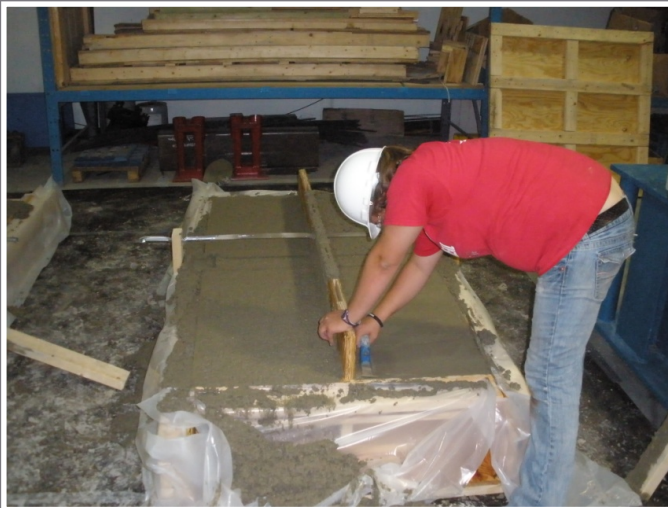
Finishing the top surface

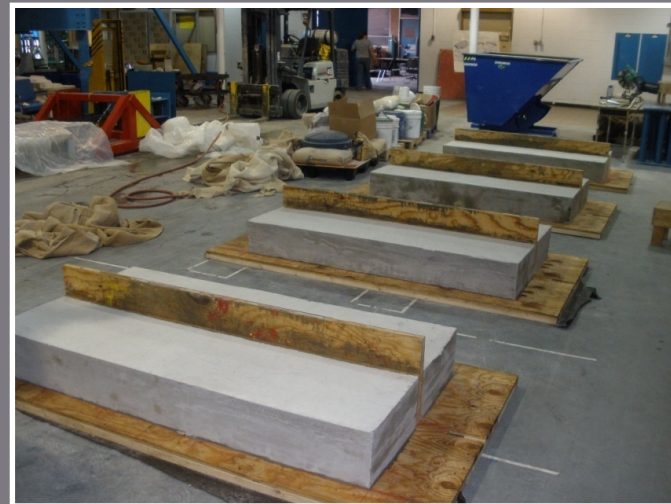
Finished Specimens
(prior to moist curing)

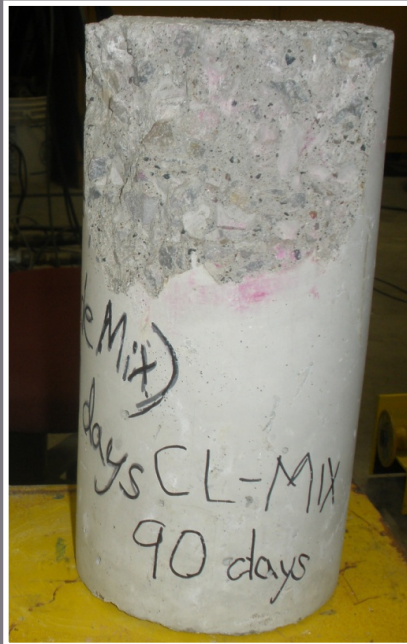
WITH CHLORIDE

PH at 90 day

Deep Purple Indicator:

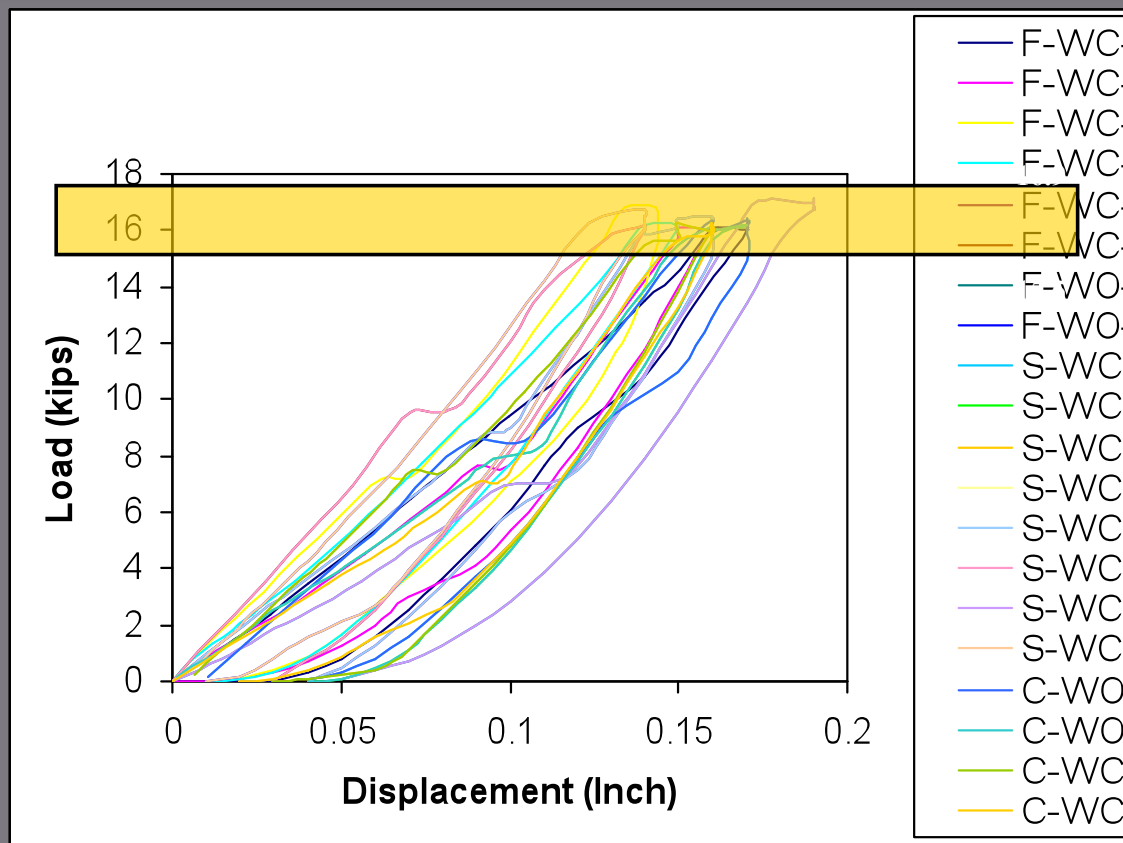
Cracking – prior to durability testing

Cracks width ranged from 0.001 to 0.005 inch (ACI 224-01)

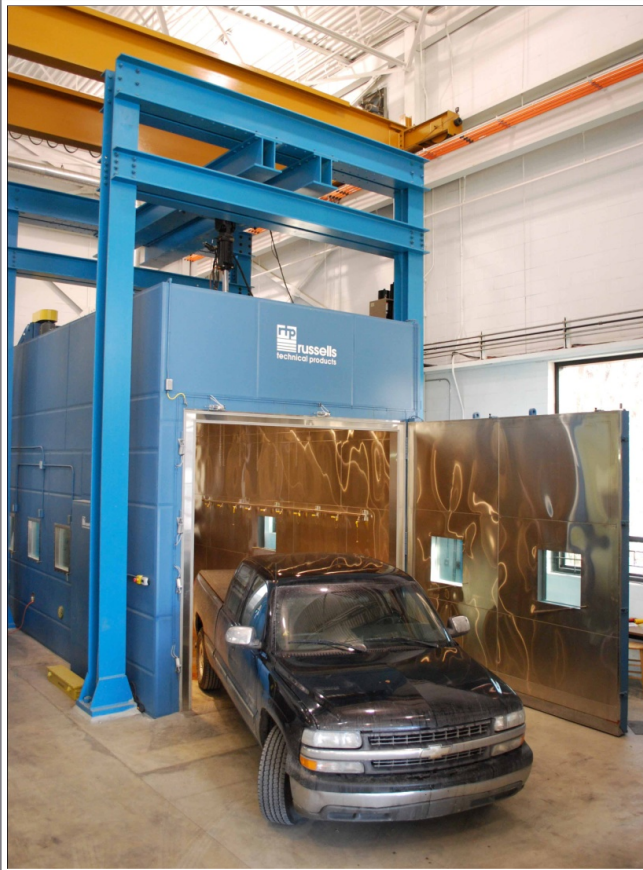
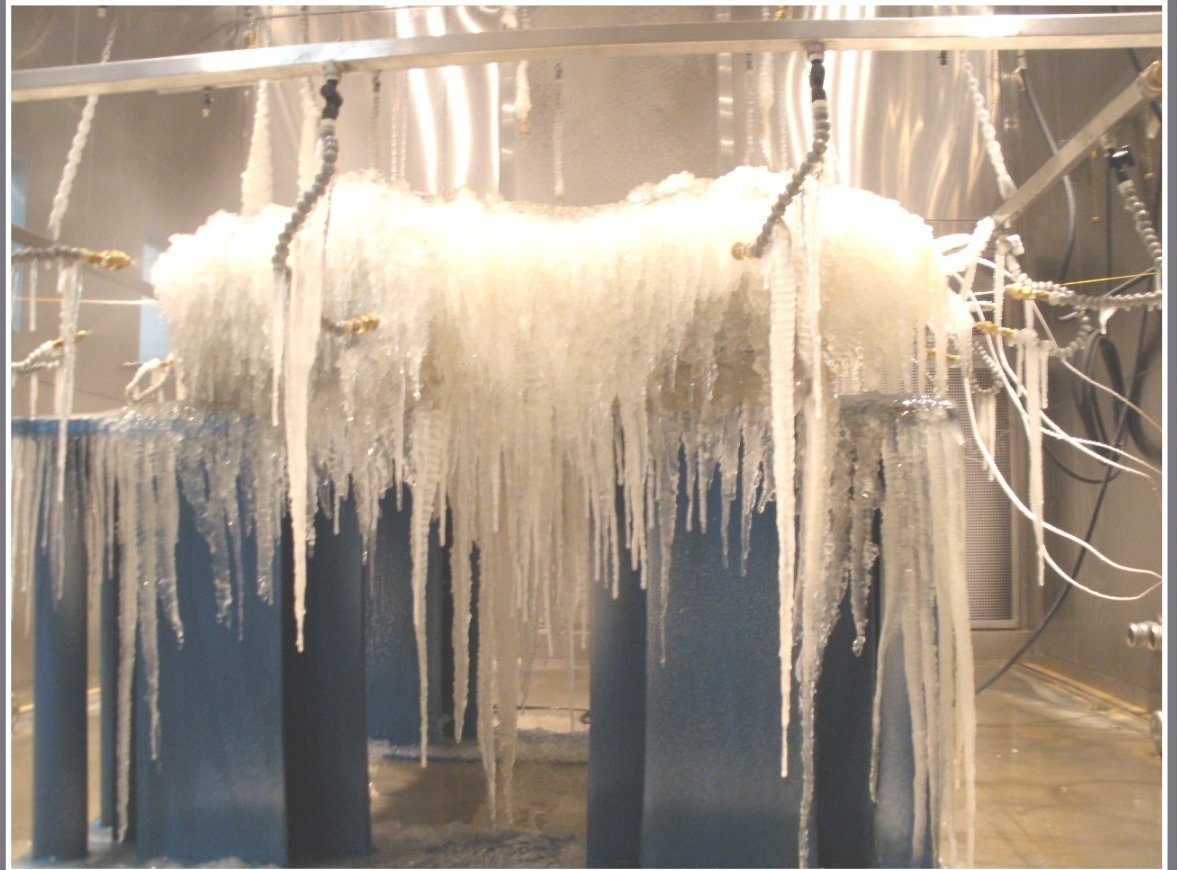
Environmental Chamber , F-T

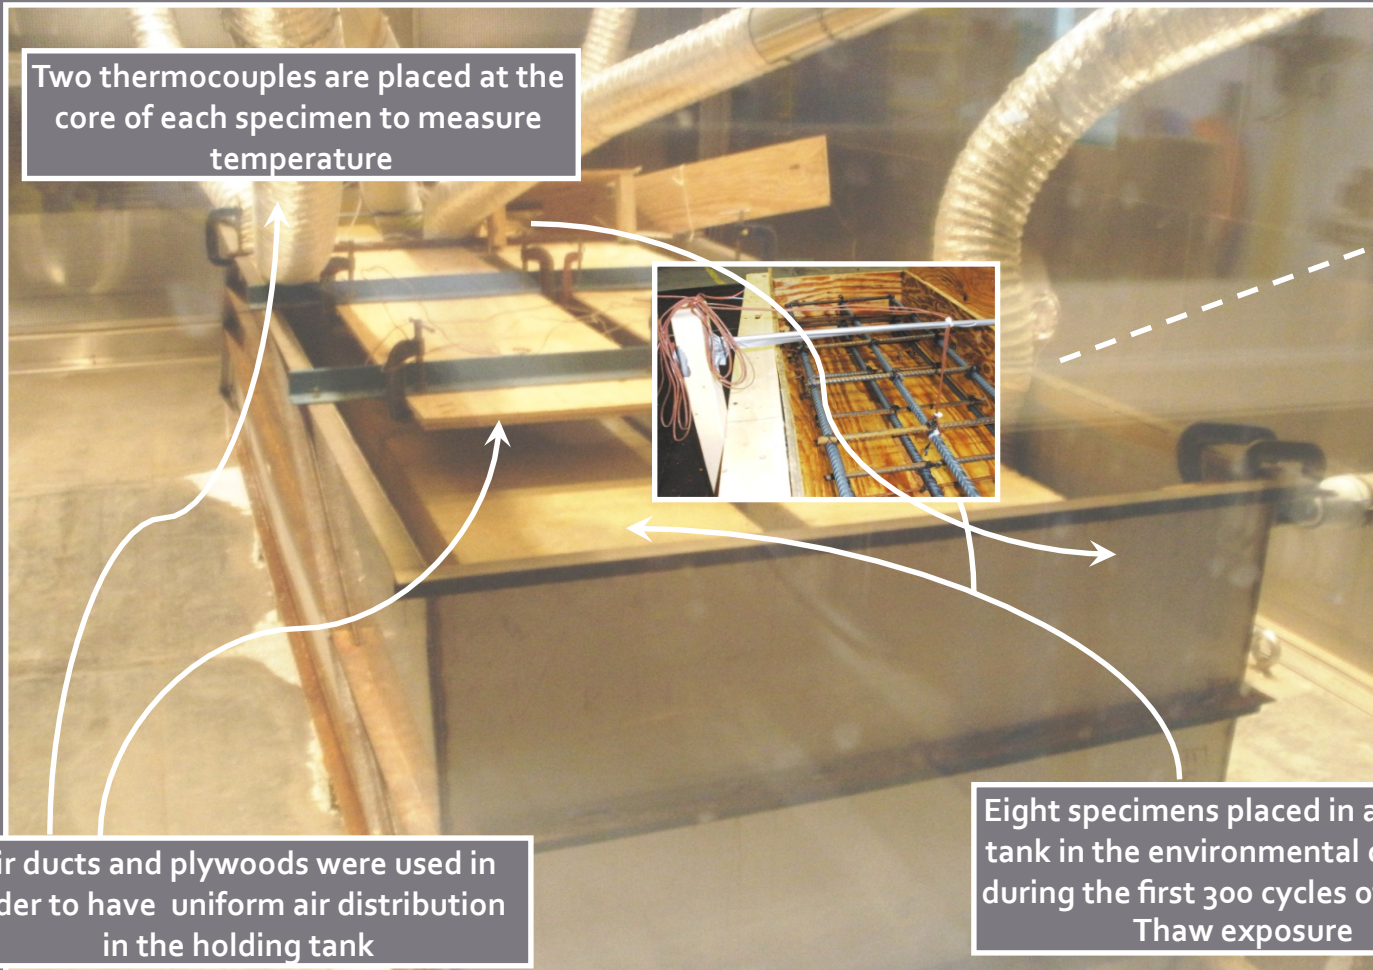
Two thermocouples are placed at the core of each specimen to measure temperature

Temperature readings have been collected for 24 hours/day

Air ducts and plywoods were used in order to have uniform air distribution in the holding tank

Eight specimens placed in a holding tank in the environmental chamber during the first 300 cycles of Freeze-Thaw exposure

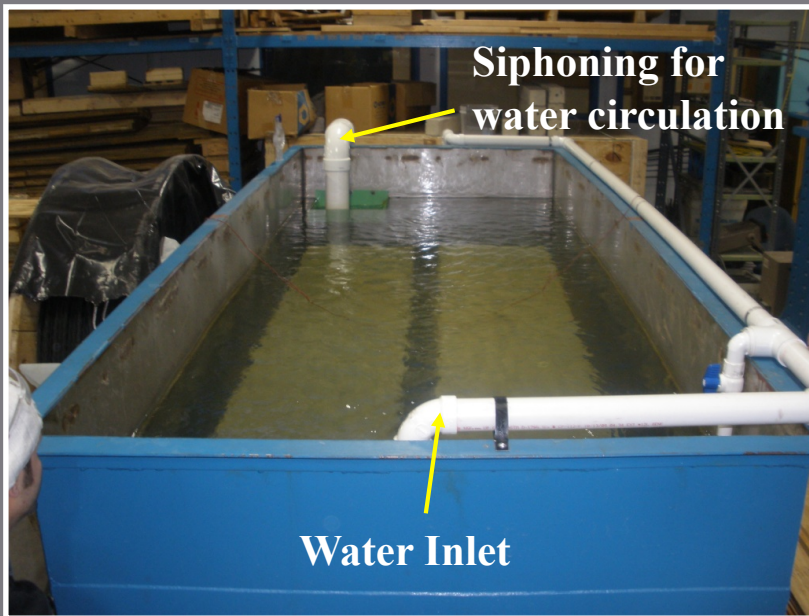
Salt-Water Exposure

Specimens placed inside the Salt Water Tank

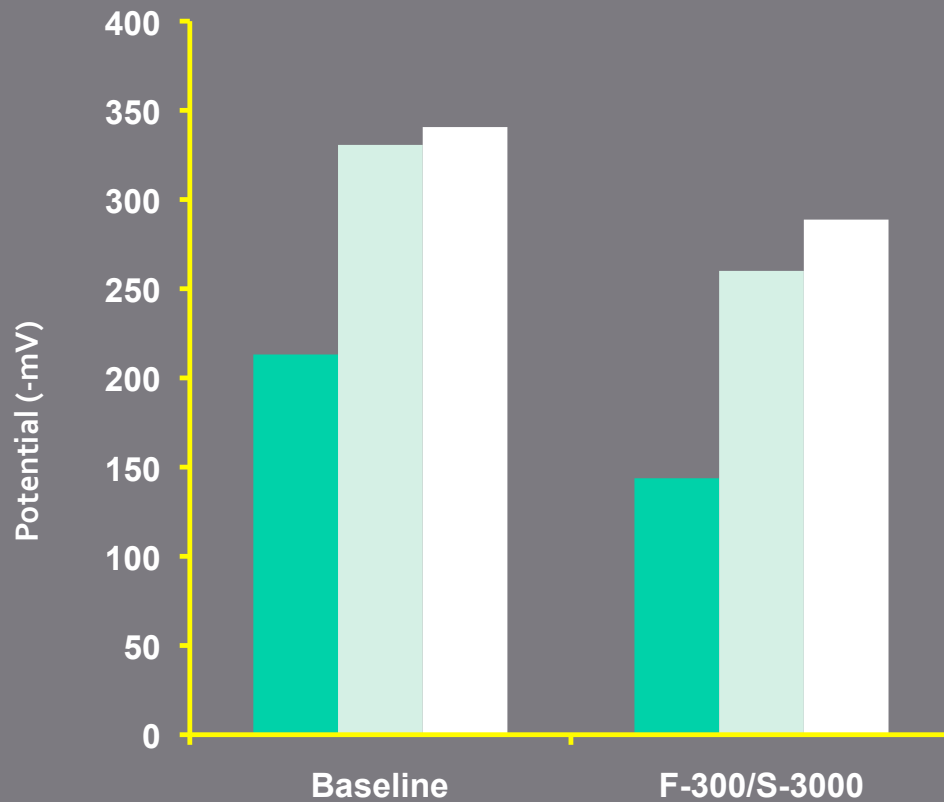
Corrosion Potential

CANIN Instruments
(Copper Sulfate)

- Control
- 300 cyc. F-T
- 3000 hrs. Salt-Water

F-300: after 300 F-T cycles;

S-3000: after 3000 h of Salt-Water exposure

Baseline: after 28 days of moist curing

- Active corrosion developing in CL doped members
 - > 50% risk of corrosion
 - $\approx 50 - 100 \mu\text{m}/\text{year}$
- Load response not affected by concrete degradation at this stage
- Exposure sequence continued

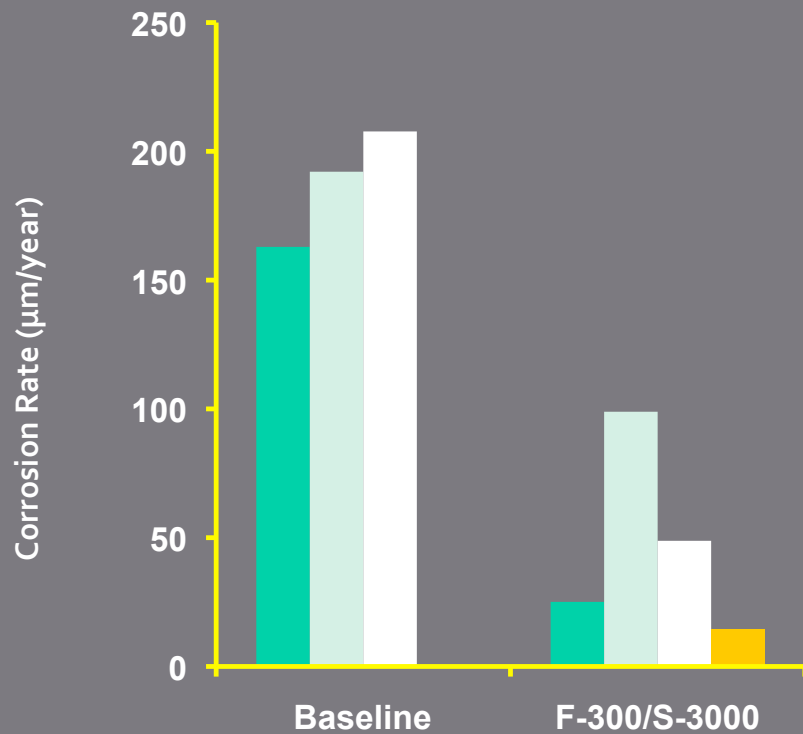
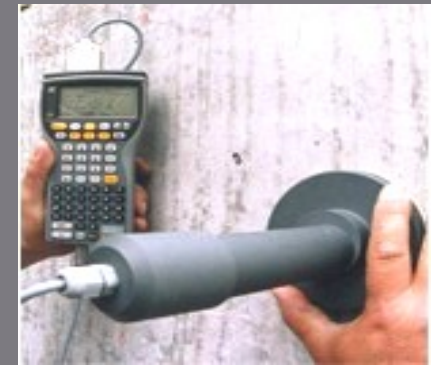
Corrosion Rate Assessment

GalvaPulse Instrument

- Control
- 300 cyc. F-T
- 3000 hrs. Salt-Water
- Extra Specimen

F-300: after 300 F-T cycles; S-3000: after 3000 h of Salt-Water exposure
Baseline: after 28 days of moist curing

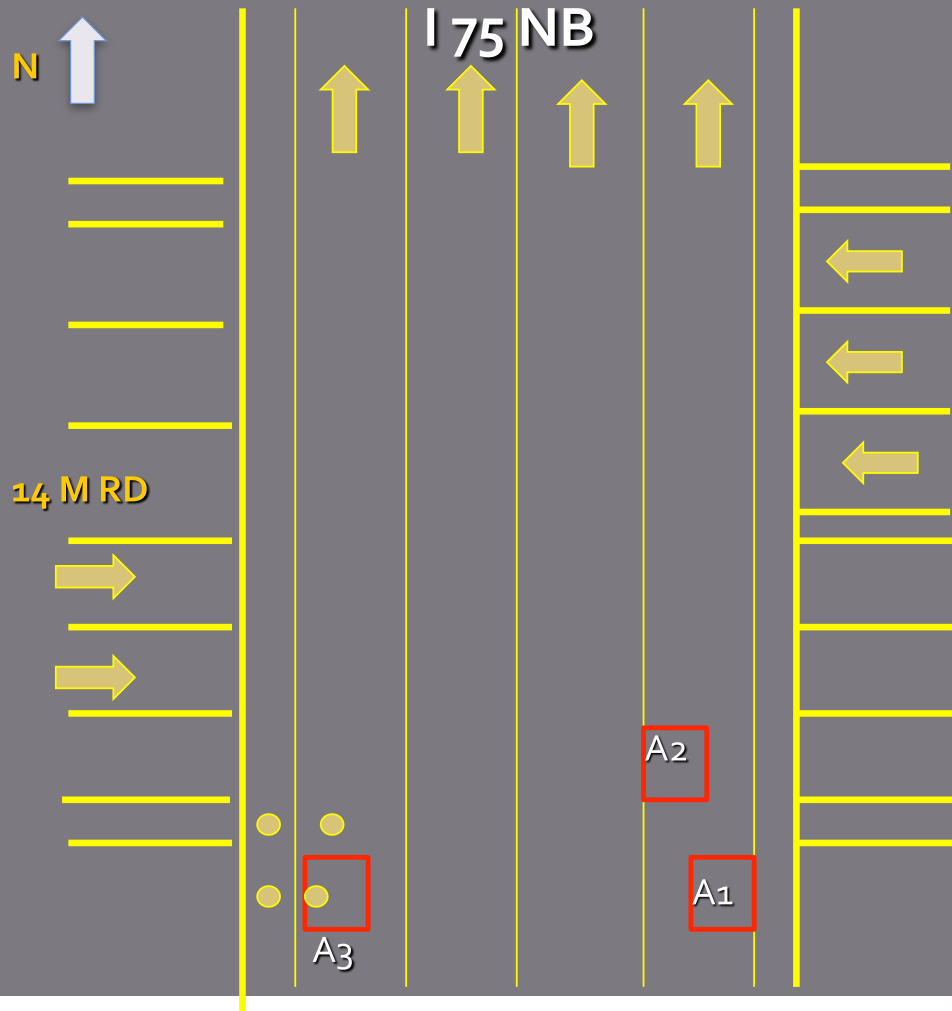
63174-S05-1 I-75 NB 14 MILE RD

A1: NDT over walk path and embankment

A2: NDT over EB 14 mile Rd

A3 : NDT over walk path and embankment

Visual inspection (above & below)

● : Coring location

NB: Areas A1 and A2 in deceleration lane

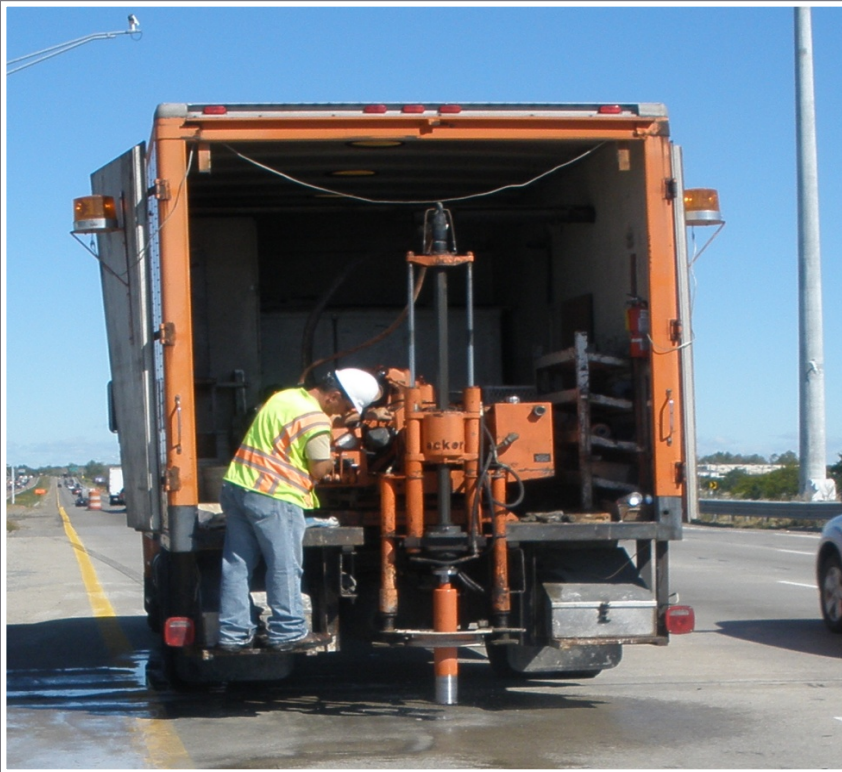
Coring full depth of the deck

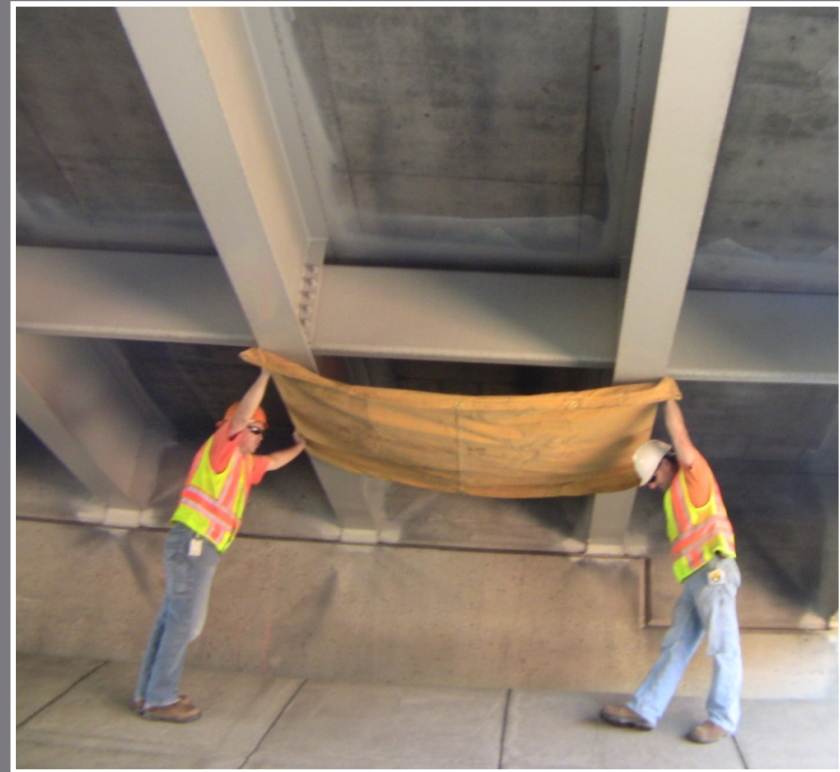
Collecting the core

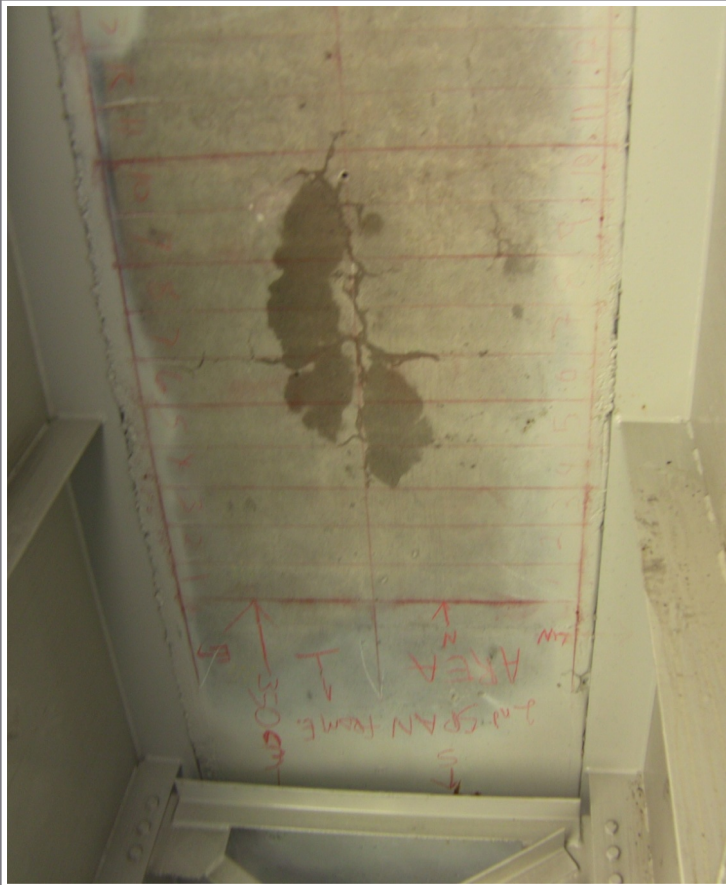
Test grid in survey area

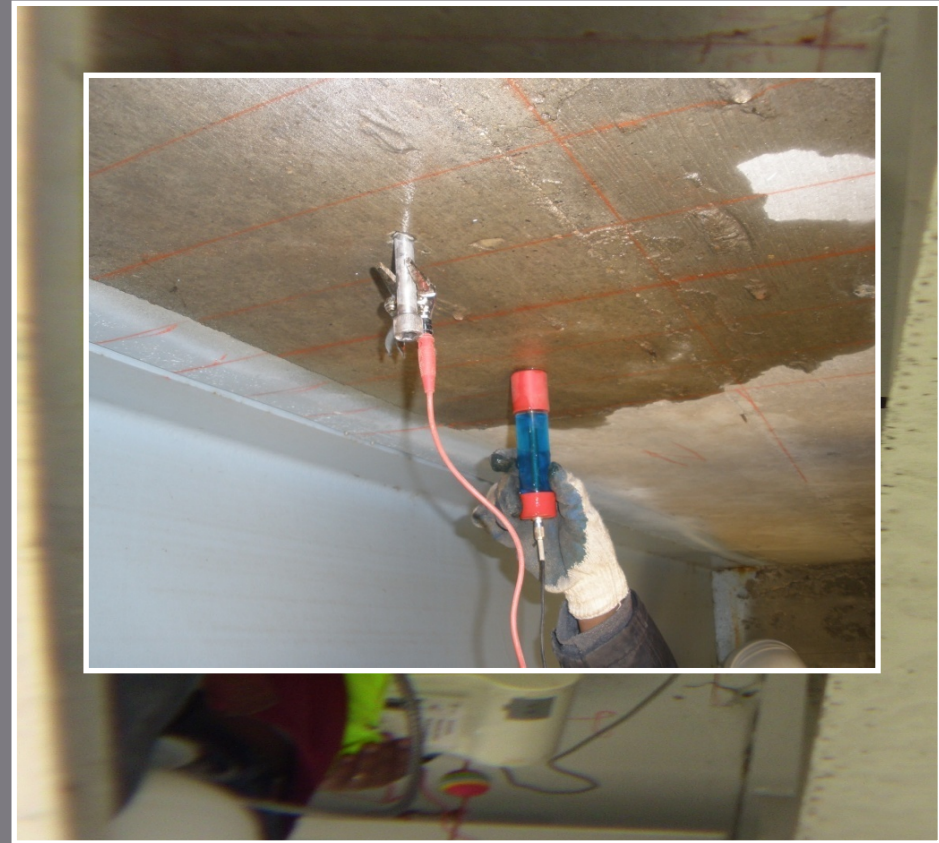
Measurement of Electrical Potential 32

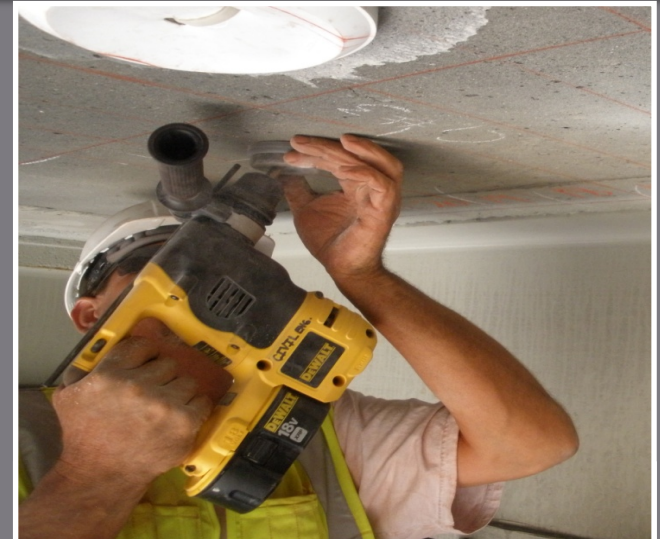
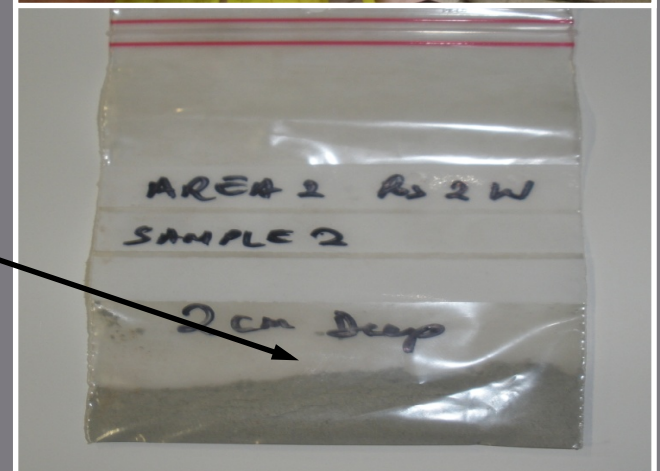
Chloride Sampling – Rapid Chloride Test

12 - 16 samples collected from different depth.

Average weight of sample is 9.0 gm

Sample of concrete dust from Area 2 at a depth of 2cm.

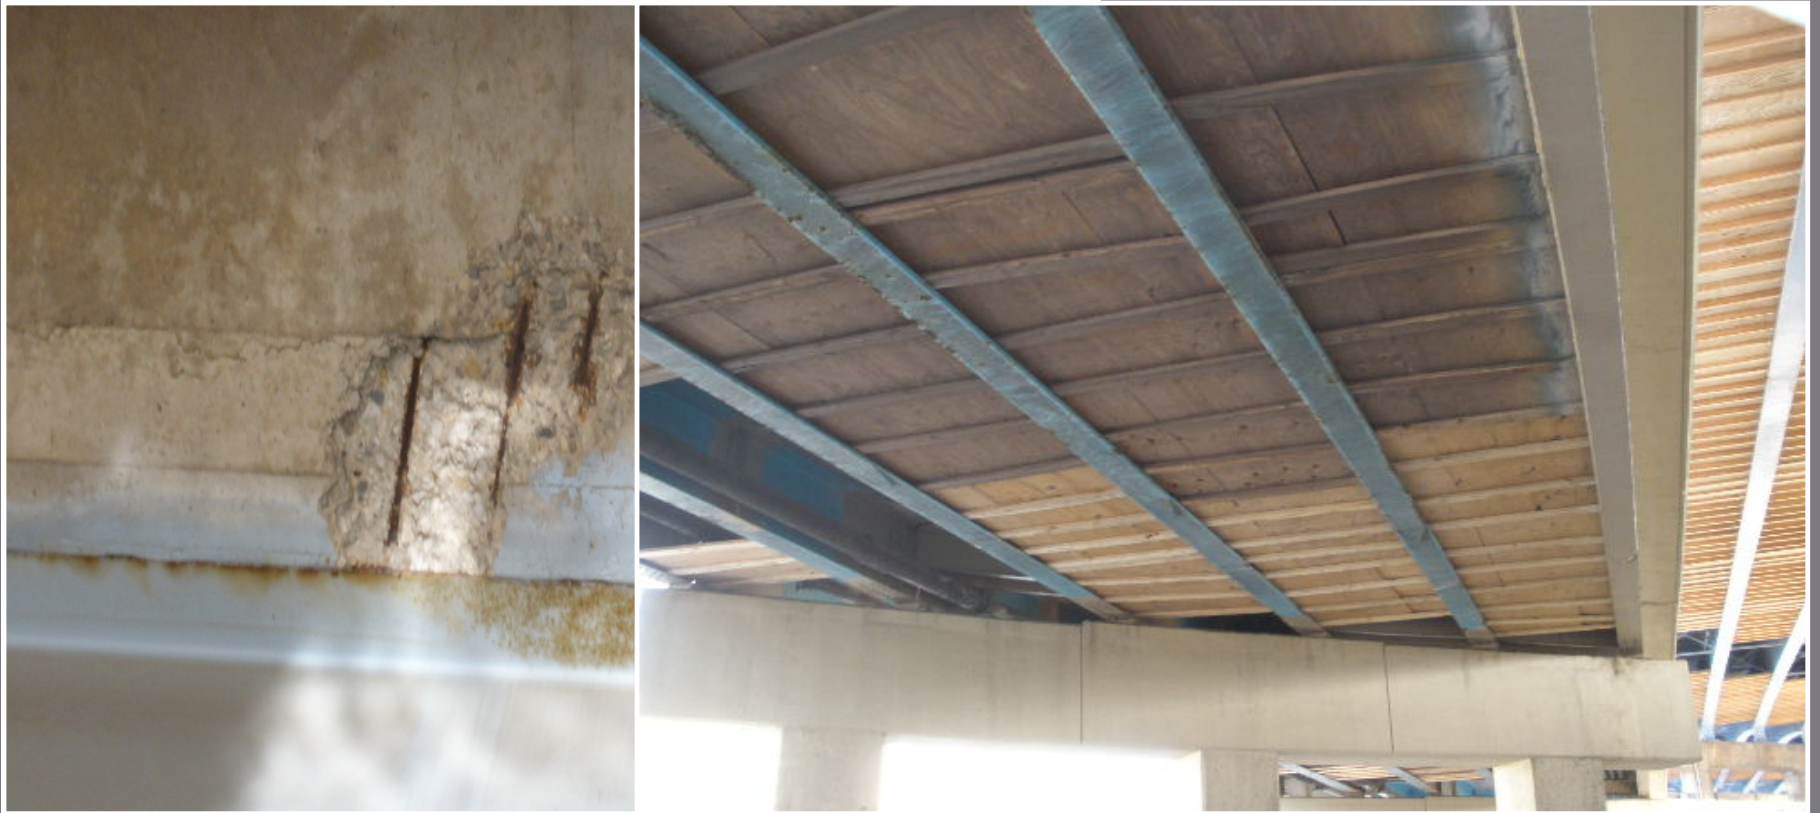
Risk of Corrosion

Location	Area 1	Area 2	Area 3
Average Potential (mV)	-315	-220	-150
Mean \pm Standard deviation (mV)	-357 -273	-251 -189	-161 -138
Risk of rebar corrosion	50%	50%	5%

Deck replacement scheduled

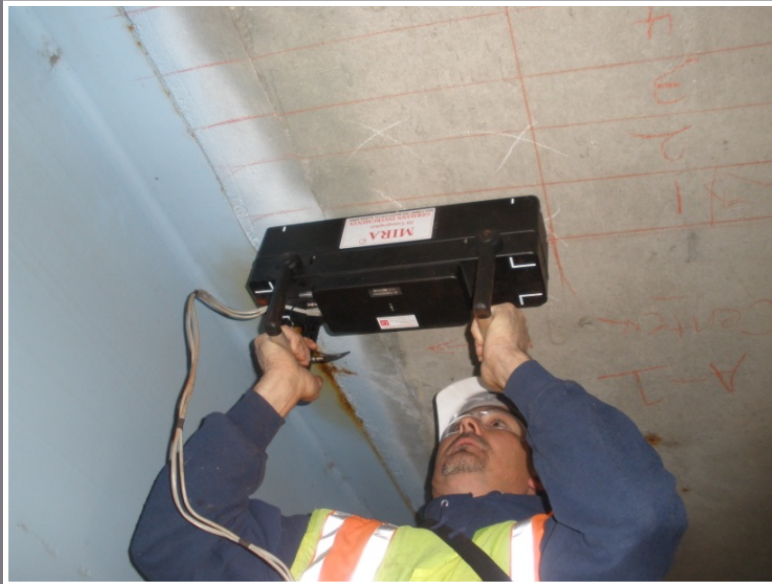
3D Tomography

MIRA
(50 Hz shear waves)
